## **"Evaluation of the restoration works of The Cenabı Ahmet Pasa Mosque with the Classical Period Ottoman Architecture example"**

**Filiz KARAKUŞ**

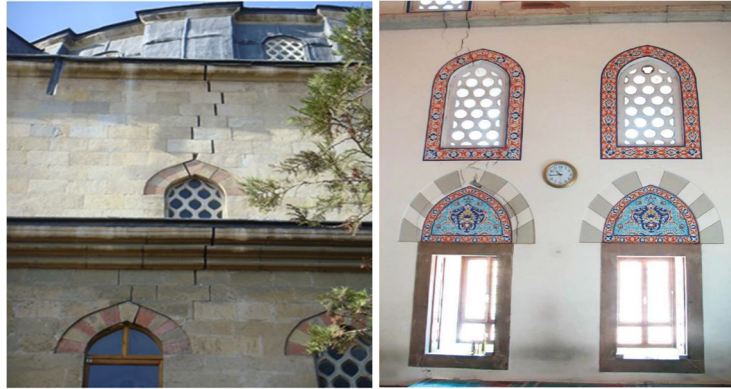
Prior to the restoration of the building that started in 2009, there was a structural crack on the eastern facade that started from the foundation and continued to the dome and expanded over time (Fig. 10). This crack is thought to be a sitting crack from the floor of the building. Apart from this structural crack; there were mass losses (deep material breaks) and superficial losses (exfoliation and pitting) in the stone material.

Apart from this, there was a moisture problem caused by roof cover and ground. Also; cement supplements on the exterior are among the reasons for this moisture. The main problem created by this moisture is the presence of water-soluble salts. During the crystallization of these salts, we see that blooming occurs on the surface of the stones on the exterior. In addition, the development of lichen and algae from moisture was among the problems on the facades. In addition to these, exterior stone surfaces had contamination caused by air pollution, traffic, and color lightening caused by day and night temperature differences and the effect of the sun.

Figure 10. Structural crack exterior and interior view (8)

After cleaning the structural cracks in the body walls of the mosque, injection was made with hydraulic lime based material. After removing the lead coating and mud plaster of the dome, the particles in the structural cracks were cleaned with an air compressor, then injection was made with a hydraulic lime-based material.

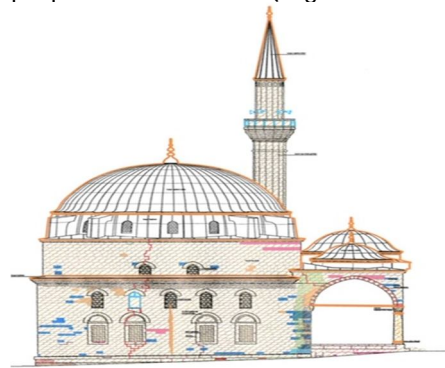
Fig. 11. Disruption map, east facade (6)

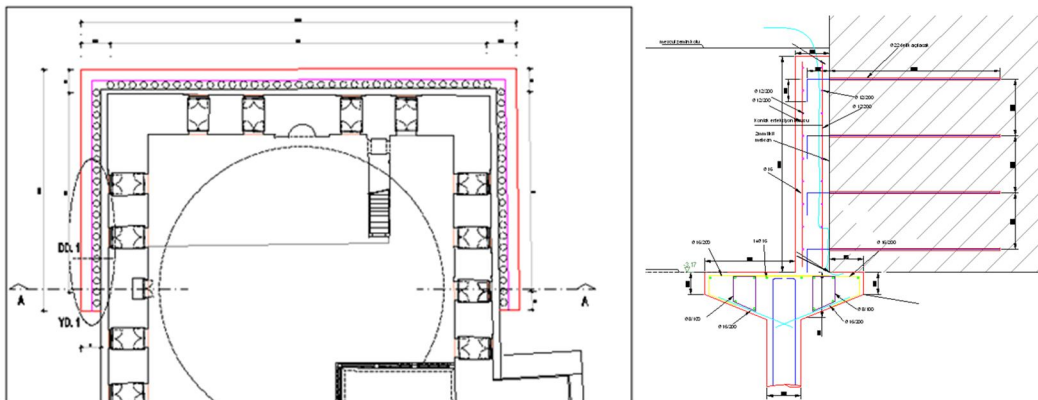
Fig. 12. Mini pile Project (left), foundation anchor, head beam and mini pile detail (right) (6)

It was decided that it would be appropriate to transfer the load transferred to the curtain wall by means of stainless steel rods anchored to the basic part at certain intervals to the mini piles by means of the head beam (Fig. 12).

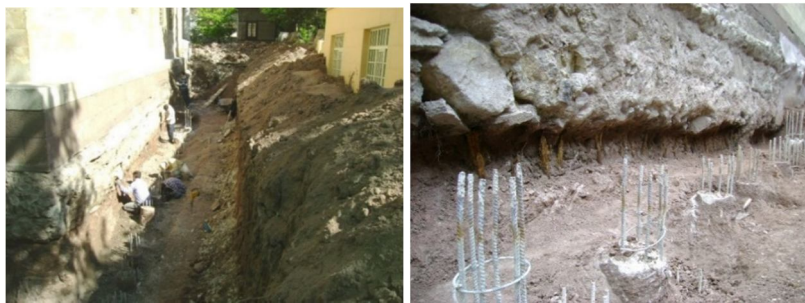
these piles were found to be rotten and inoperable. These wooden piles are placed in a single row average 70-80 cm height, 30-40 cm axis range. Excavations were left at the point where wooden piles were encountered (Fig. 13). In the next stage, the formwork and reinforcement of the head beam were prepared, the sprouts of the curtain wall were left and the concrete of the head beam was poured. Then, chemical injection process to be carried out at the mosque foundation was started. Polyurethane and silicate based

Fig. 13. Excavations and wooden piles that emerged in the meantime and newly manufactured mini piles, 2010 (8)

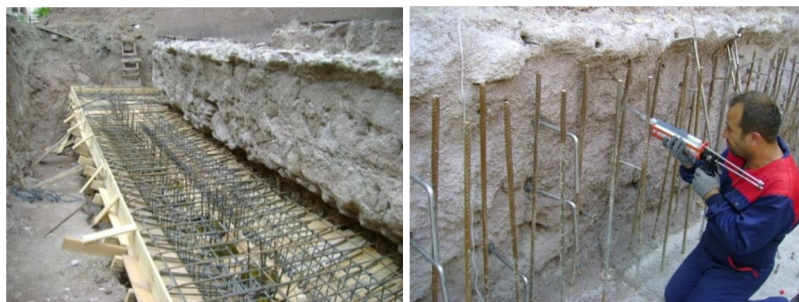
Fig. 14. Cap beam formwork and reinforcement and concrete manufacturing (left) and anchor manufacture (right) (8)

injection resin mortar was injected under controlled pressure through pneumatic hoses placed in the injection holes opened in the foundation walls of the mosque in order to increase the foundation strength by filling cracks and voids. After the double component epoxy mortar was pressed out from the bottom of the holes opened by the plastic hose, stainless steel anchor rods were placed in the holes, attention was paid to press enough epoxy (Fig. 14).

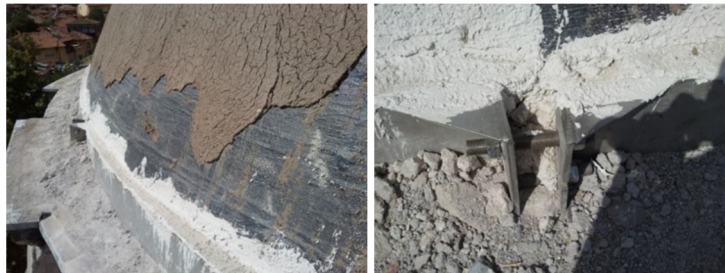
Fig. 15. Blasting with stainless tensioning application and silicium (left) and joint bolts (6)

applied with the original bricks of the dome. Then, in line with the strengthening project, a total of nine rows of carbon fiber fiber material was wrapped from the dome skirt. In this application, 60 cm overlap and fixation with 4 anchors were made. After application, sanding was done with silica sand to keep all surfaces plastered (Fig .15).

In the next stage, a tensioner was applied to the dome pulley with stainless steel material. The reason for the need for a stainless steel tensioner despite winding with a carbon fiber material; although there is no pre-tension in the carbon fiber material, a pre-tension can be applied by means of the bolts at the junction points of the stainless steel material. Later, mud plaster was made and lead cover was covered and reinforcement in the dome was completed (Fig.16).

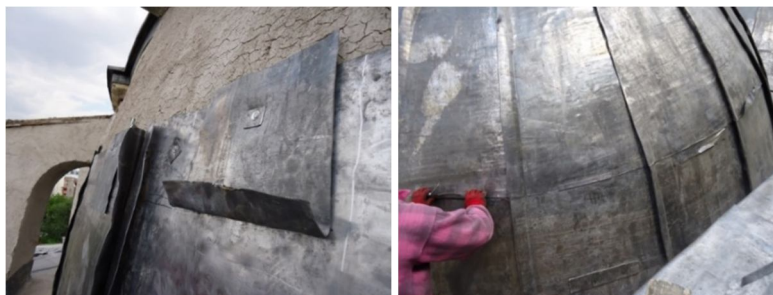
Fig. 16. Making lead covers, 2011 (8)

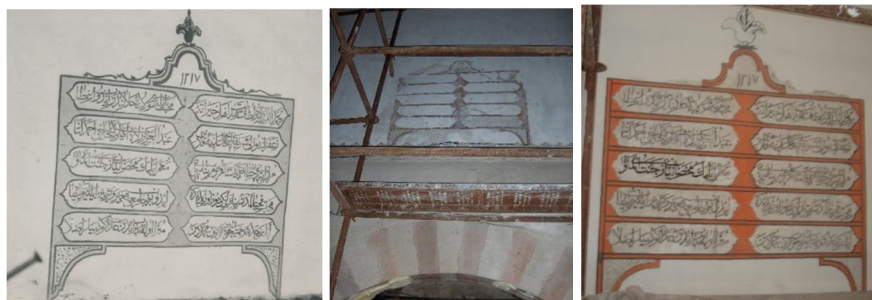
Fig. 17. Photo of inscription before 1936 (left), the inscription found on the entrance door (middle) and revival of the inscription (right) (8)

in the mentioned inscription that the mosque was repaired by "Haji Alime Woman from Zafranbolu" on 1207 (1802). This inscription was revealed, revived by cleaning and completing the missing paints (Fig. 17).

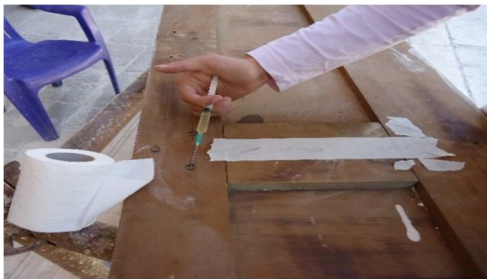
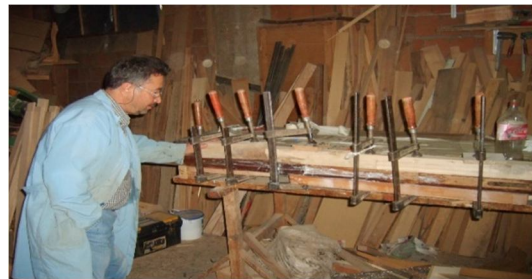
Fig. 25. Conservation of the wooden entrance door

**Cleaning and restoration of architectural elements in the mosque:** The wooden elements (shutters, entrance doors, etc.) of the mosque were cleaned by injection method. In addition, conservation of the the wooden entrance door was done (Fig. 25).

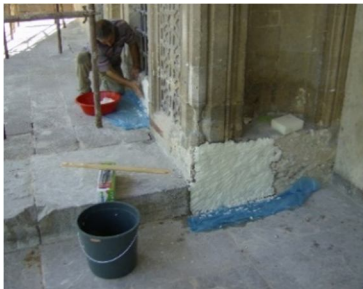
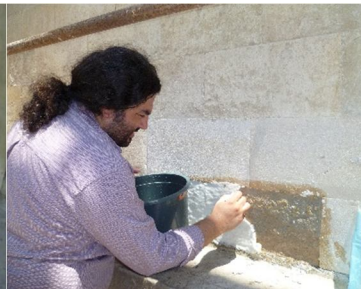
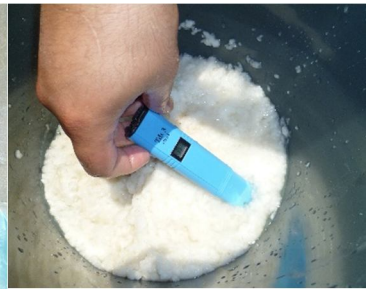
Fig. 26. Blasting and salt cleaning of cement imitations

In the window iron railings, paint and rust cleaning was done first. Then anticorrosion and black matte paint was applied on it. Cement imitations on the exterior of the mosque were carefully cleaned and then salt extraction (cleaning) was done (Fig. 26).

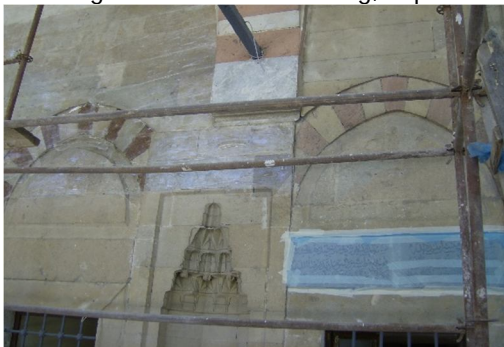
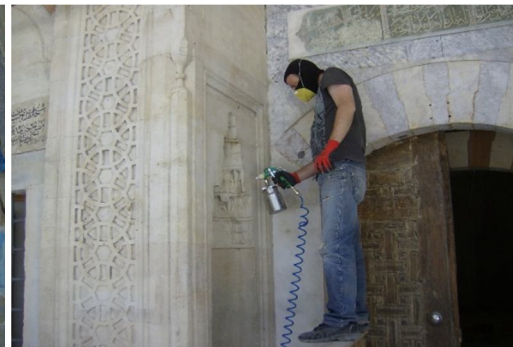
Fig. 27. Cleaning and protective application on exteriors

After the salt cleaning process, exterior cleaning was done by using granular spraying using sodium bi carbonate. In the front facade and marble columns, cleaning was done using AB 57. Following exterior cleaning, plastic

repairs were made in the sections where cement was cleaned. Then, three layers of Paralodid B-72 (1st layer 3%, 2nd layer 5% and 3rd layer 10% solution) were applied to protect the Stones (Fig. 27).

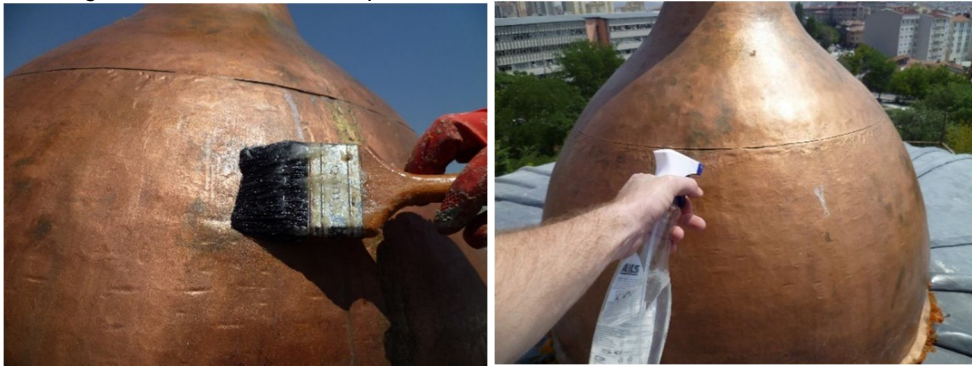
Fig. 28. Cleaning and protecting of copper finials

After the application of lead in the dome, the missing boiler part of the copper finial in the main dome and other missing realms were completed and

cleaning was done on other surfaces. Paraloid B-72 was then applied to these surfaces as a preservative (Fig. 28).
