## **"Evaluation of the restoration works of The Cenabı Ahmet Pasa Mosque with the Classical Period Ottoman Architecture example"**

**Filiz KARAKUŞ**

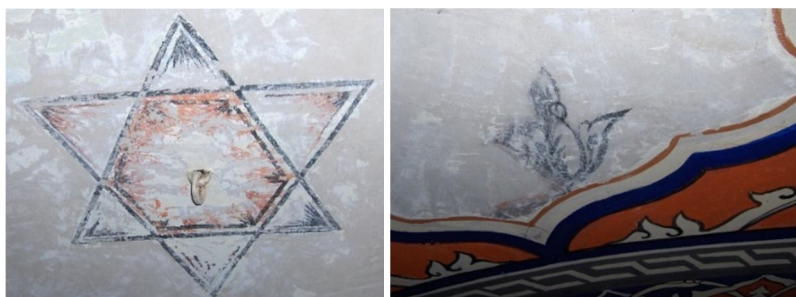
Fig. 18. Motifs revealed during the scraping of the mosque dome, 2010 (8)

The motifs in the mirror parts of the window arches, pendants and domes, which are thought to have been made in the early 19th century and reflect the baroque effects (Fig. 19), were removed in the restoration that started in 1936. Instead of these, wall paintings with vegetal motifs were carried out reflecting the 16th century decoration understanding. In the scraping carried out in the mosque, motifs in the dome emerged from the baroque period that were covered (Fig. 18). With the idea that baroque motifs can be found, scraping has been done in other regions. However,

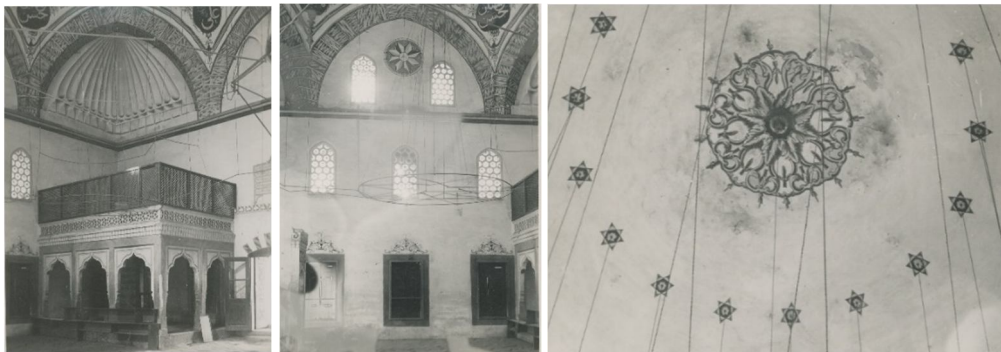
according to Fig. 20, nothing emerged from the scraping done in wall paintings, which should have a star motif in its lower layer (Fig. 19). In the scraping carried out in one section of the dome, no traces of other periods of the building were found. For this reason, in accordance with the Ankara Cultural and Natural Heritage Conservation Regional Board Decision dated 02/07/2010 and numbered 5199, the star motifs emerging in the dome and the palmettes emerging around the dome core were preserved as they were and the scraper cuttings were completed in the dome (Fig. 21).

Fig. 19. Photograph of the mosque interior and dome before the repair in 1936 (6)

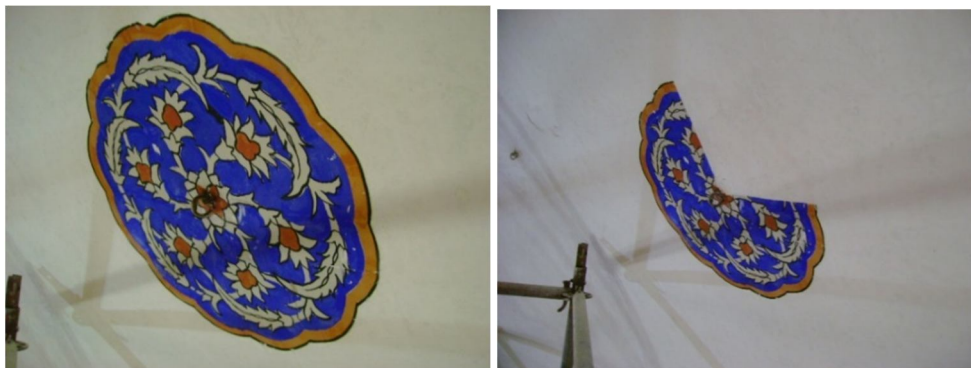
Fig. 20. Scraping made in the dome of the mosque, 2010 (8)

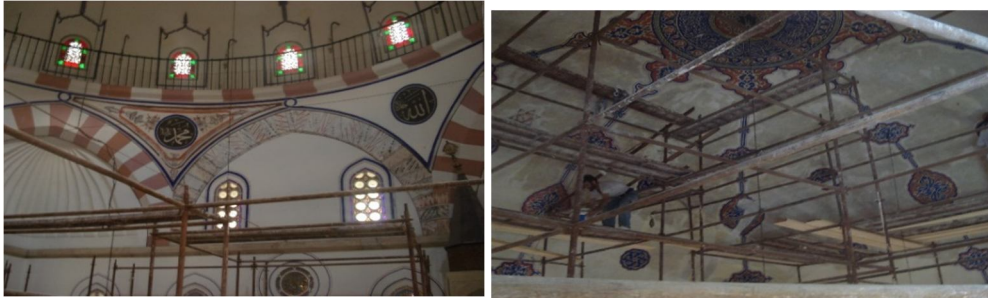
Fig. 21. Wall paintings, 2010

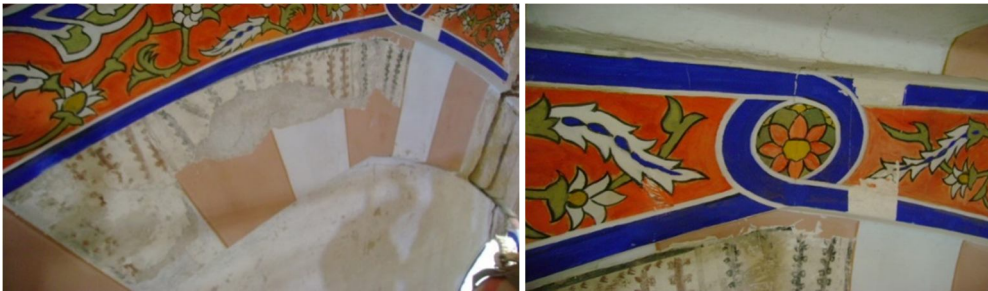
In the scraper on the arches bearing the dome, motifs that were thought to have been made in the baroque period in the 19th century were unearthed. However, no traces of other periods could be found under the wall paintings on these arches (Fig. 21).

Fig. 21. Scraper on the arches, 2010 (8)

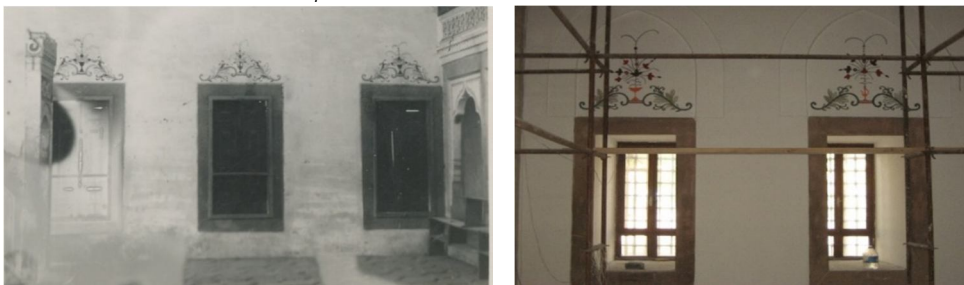
No traces were found in the scraper made to reveal the baroque motifs seen in Figure 22(left) in the mirrors. For this reason, it is believed that the internal plaster was renewed in repairs made in various periods. In line with the decision of the Board mentioned above, in the

Fig. 22. Motifs on the window mirrors (left) and the motifs made in the north facade mirrors, 2010 (8)

interior; the existing motifs in the mirrors of two of the lower windows on the north facade were removed and motifs reflecting the 19th century baroque effects seen in the old photographs were done (Figure 22-right).

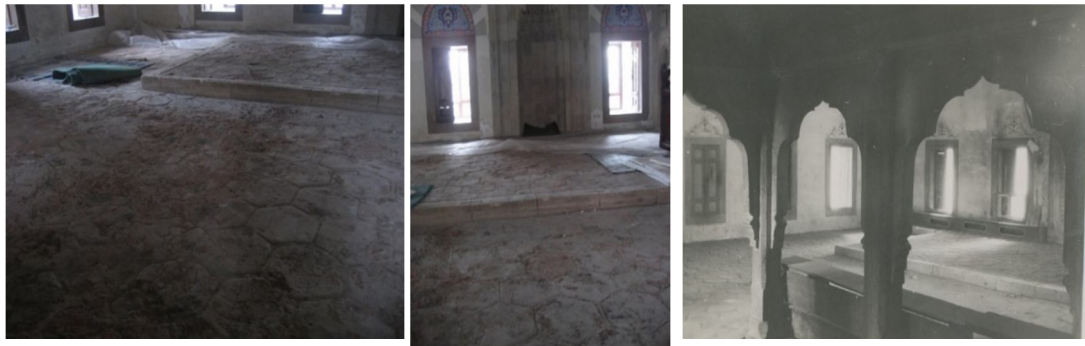
**Reconstruction and restoration of elements lost in time:** In accordance with the approved project, the screed in the harim floor was carefully removed and the brick floor seen in Fig. 23(left) was revealed. In Fig. 23(middle), it is seen that the section with the mihrab and the minbar is raised by one step and its

surround is framed by a clamped stone. The brick flooring of the mosque is clearly visible from the photographs before the repair, which started in 1936 (Fig. 23-right). In addition, in the harim, stone jamb, mihrab, pulpit, stone railings and stone pillars were cleaned with AB 57 material (Fig. 24).

Fig. 23. Brick flooring emerging under the screed (left), brick floor in front of the mihrab (middle) (8) and photograph of the mosque flooring before the repair in 1936 (right) (6)

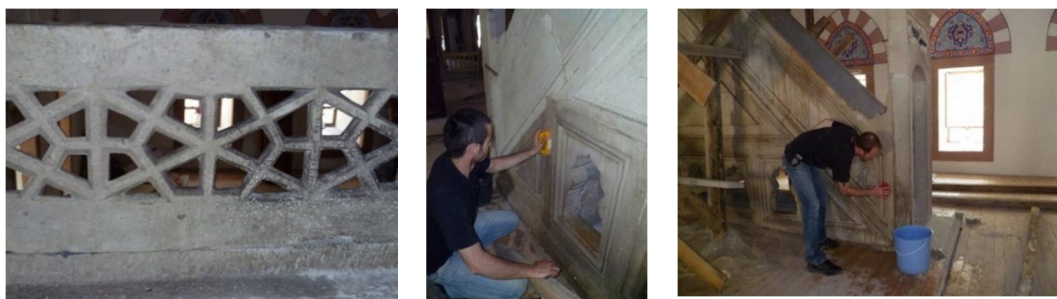
Fig. 24. Cleaning work on mahfel railings and minbar (8)
